Role of Starting Material Composition in Interfacial Damage Morphology of Hafnia Silica Multilayer Coatings

This paper was prepared for submittal to the
30th Boulder Damage Symposium: Annual Symposium on
Optical Materials for High Power Lasers
Boulder, Colorado
September 28 - October 1, 1997

Role of starting material composition in interfacial damage morphology of hafnia silica multilayer coatings

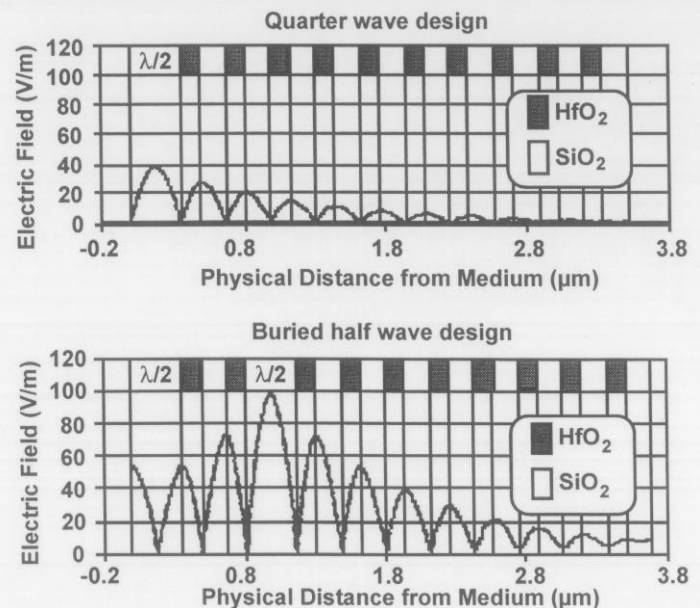
To improve understanding of the role of electric field on both interfaces, a buried half-wave design was developed to shift the electric-field peak in the outer layers from the hafnia grown on silica interface to the silica grown on hafnia interface as illustrated in figure 2. The symmetry of the electric field profile, calculated with Macleod Thin-Film Design Software,⁸ within this design provides an opportunity to simultaneously expose the two different interfaces to high electric fields to determine differences in interfacial strength between the two different materials. In addition to shifting the electric-field peak locations, the peak amplitude was also unfortunately significantly increased. Therefore it is anticipated that the damage threshold of the buried half-wave coating will be lower than the all quarter-wave design.

Fig. 2 Electric-field profile amplitude and interface peak locations are different for the two designs.
